SHIPOWNERS
SECURITY FOR SMALL & SPECIALIST VESSELS

► BULLETIN

Guidance on snap-back zones

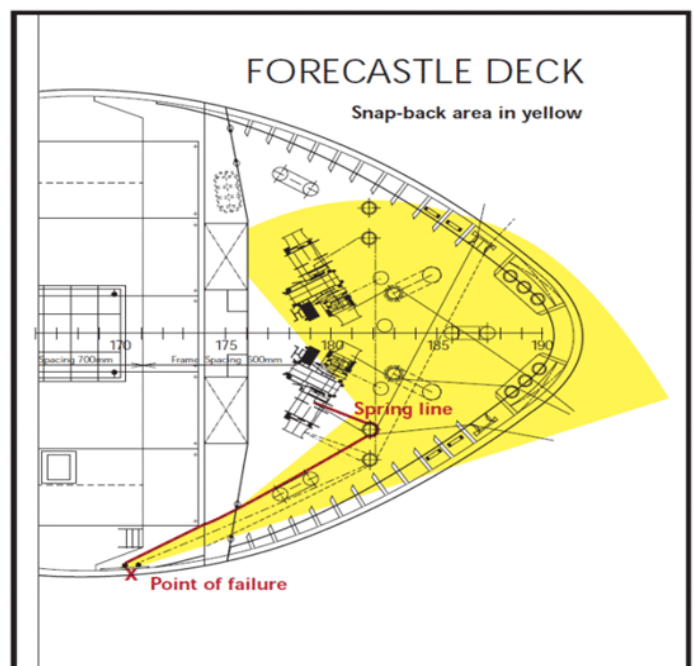
The diagram shows the potential area of danger (snap-back zone) when the spring line parts at the spring line fairlead. The snap-back zone would be increased if both pedestal fairleads were used. (Swedish Accident Investigation Authority Report S-95/11 Morraborg)

It recommends that the entire mooring deck should be considered as a potential snap-back zone and clear visible signage must be displayed to warn the crew. It is also recommended that a bird's eye view of the mooring deck is produced to identify potentially dangerous areas. The diagram below is an extract from the COSWP and gives an example of how the snap-back zone may be depicted on a mooring plan.
