► **LOSS PREVENTION  
FISHING VESSEL SAFETY**

## ► Contents

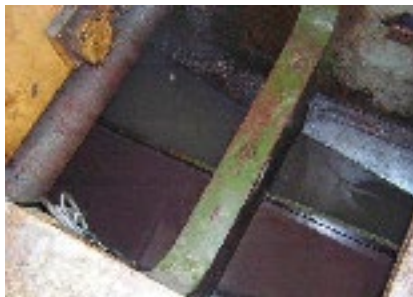
Figure 8: Bilges containing water

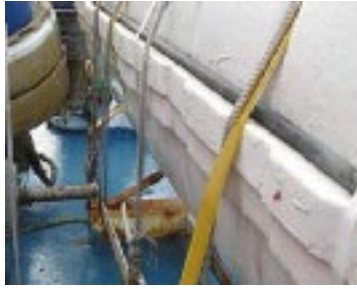
Figure 10: Incorrectly stowed life raft

- Survival craft (weekly) – attention should be paid to ensure the correct installation of the hydrostatic release unit (HRU). Figure 10 illustrates an incorrectly stowed life raft (without a HRU), Figure 11 illustrates correct stowage.
- Alarm signals (weekly).
- Life saving equipment, including fire extinguishers (at least every four weeks).
