► **LOSS PREVENTION  
FISHING VESSEL SAFETY**

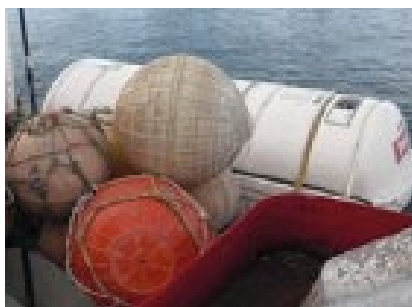
Figure 1: Obstructed life raft

2. The location and operation of safety equipment, ensuring it is free from obstruction (Figure 1).
3. The on board layout of the spaces such as void spaces, engine room and cargo spaces.

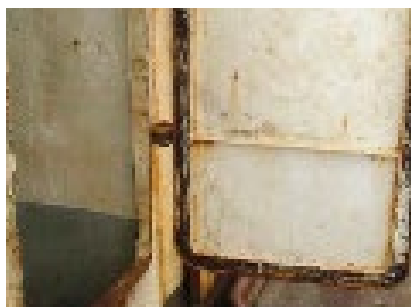
Figure 2: Poorly maintained rubber seals on weather tight doors

It is essential that all openings to the sea have the ability to be made watertight to ensure that water does not ingress during normal operations, when transiting or in an emergency. These items include hatches, doors and vents. During maintenance, rubber seals must be checked for deterioration and all closing devices must be in place with the ability to close fully. During the Club's routine Protection and Indemnity (P&I) Condition Surveys on fishing vessels, the poor maintenance of watertight openings is often noted (Figure 2).

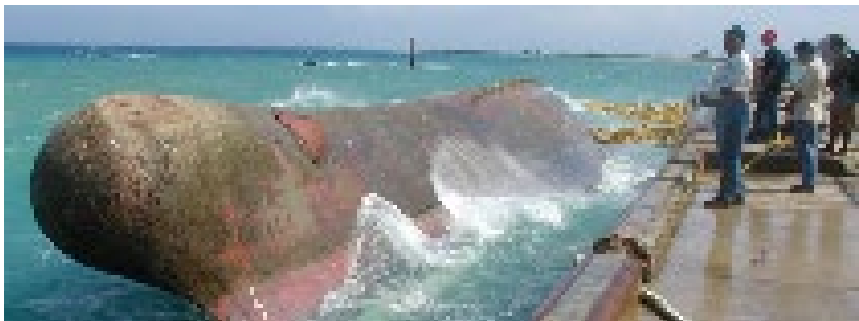
Figure 3: Capsized fishing boat

Other reasons for a vessel to capsize include:

- Free surface effect caused by flooding, therefore reducing stability.
- Free water on deck.
- Ice accumulation in freezing conditions on the vessel's steelwork and fishing equipment, including pots.
- Incorrect stowage of fish.
- Lifting weights by derrick, therefore changing the vessel's centre of gravity.

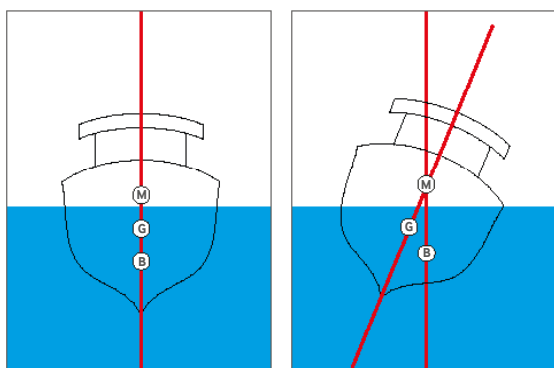
Figure 4: Diagrams to illustrate Centre of Gravity and Buoyancy, Metacentric height and Metacentre

All skippers should be aware of their vessel's stability characteristics, how to calculate the prevailing stability condition and the basic terminology used, as follows (see Figure 4):

- Centre of Gravity (G) is the point at which all the mass of body may be considered to be concentrated.
- Centre of Buoyancy (B) is at the centre of gravity of the underwater volume.
- Metacentric height (GM) is the distance between the centre of gravity of a ship and its Metacentre (M) – the point on the centre-line of a vessel through which all the forces of buoyancy pass when the vessel is heeled.

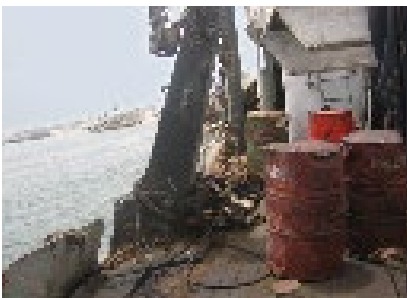
Figure 5: Working deck with many obstructions and dangers

The vessel's working areas should be well lit and, so far as possible, free from any obstructions or potential dangers (Figure 5). Crew members' awareness of lines under tension and snags on the lines or visible bights is vital.

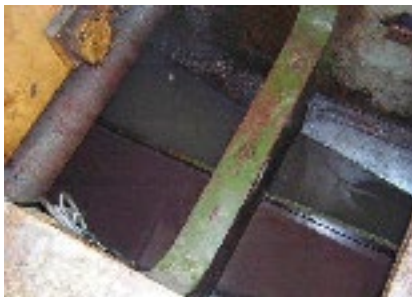
Figure 8: Bilges containing water

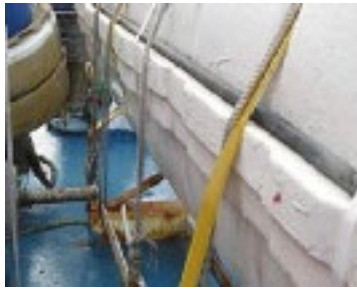
Figure 10: Incorrectly stowed life raft

- Survival craft (weekly) – attention should be paid to ensure the correct installation of the hydrostatic release unit (HRU). Figure 10 illustrates an incorrectly stowed life raft (without a HRU), Figure 11 illustrates correct stowage.
- Alarm signals (weekly).
- Life saving equipment, including fire extinguishers (at least every four weeks).

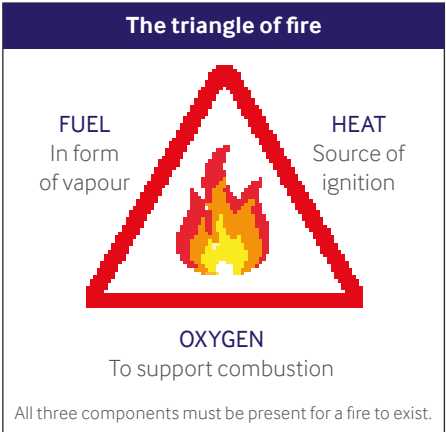
Figure 12: The triangle of fire

- The principles of firefighting, including The Triangle of Fire (Figure 12).
- How to use basic firefighting equipment (including fire blankets).
- The areas most likely to be susceptible to fire hazards, such as the engine room, galley, accommodation spaces, storerooms and wheelhouse.
- Fire hazards, such as oily rags, grease on electrical equipment, cookers and hot surfaces, drying clothes over heaters, stoves and smoking in bunks.

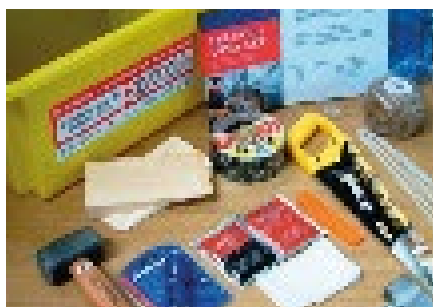
Figure 13: Typical damage control kit

Many incidents and vessel losses are the results of flooding. Fishermen are taught little about preventing their vessels from sinking once water ingress begins. Prevention could be achieved by thorough and regular maintenance, but saving the vessel during a flooding incident could be achieved by having knowledge of damage control and the right equipment on board (i.e. Damage Control Kit – Figure 13).

Suggested items to include in a Damage Control Kit are:

- Amalgamating or duct tape.
- Assorted pieces of timber (sheet and 0.6m x 0.6m shoring).
- Clamps – jubilee and hose clips (preferably stainless steel) in assorted sizes.
- Epoxy resin stick.
- Flashlight(s).
- Gland and seam packing material.
- Hammer.
- Hatchet and/or axe.
- Heavy twine.
- Knife with a serrated edge.
- Saws (wood and hacksaws).
- Screwdrivers.
